Former Plainwell Impoundment and Plainwell No. 2 Dam Area 2012 Bank Conditions Monitoring Report - Addendum 1

Addendum 1 to the Former Plainwell Impoundment and Plainwell No. 2 Dam Area 2012 Bank Conditions Monitoring Report: Bank Maintenance Completion Memorandum for Plainwell Impoundment Western Channel, Removal Areas 4A and 6B; and Plainwell No. 2 Dam Removal Area 3A

ALLIED PAPER INC./PORTAGE CREEK/
KALAMAZOO RIVER SUPERFUND SITE

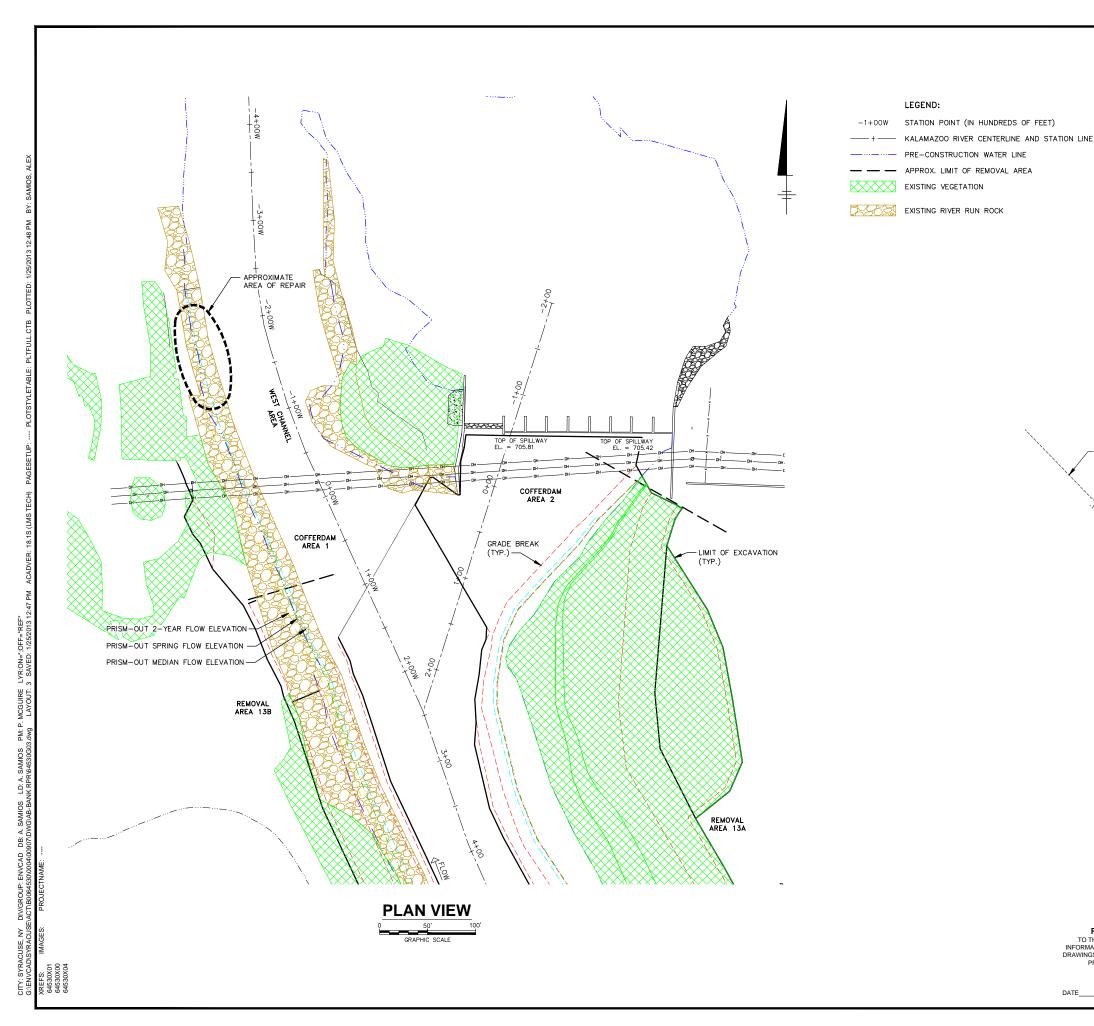
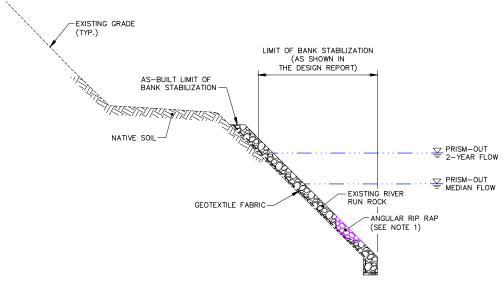
FIGURE 3

During the week of December 17, 2012, approximately 15 cubic yard (cy) of angular rip rap was installed in an approximately 50 linear feet (ft) and 10 vertical ft area of exposed geotextile fabric on the south bank of the Western Channel downstream of the former Plainwell Dam (Figure 3). Rock was placed using a long-reach excavator situated at the top of bank. ARCADIS verified completion of rock placement by visual observation that geotextile fabric was no longer exposed. The bank slope was not altered by the maintenance.

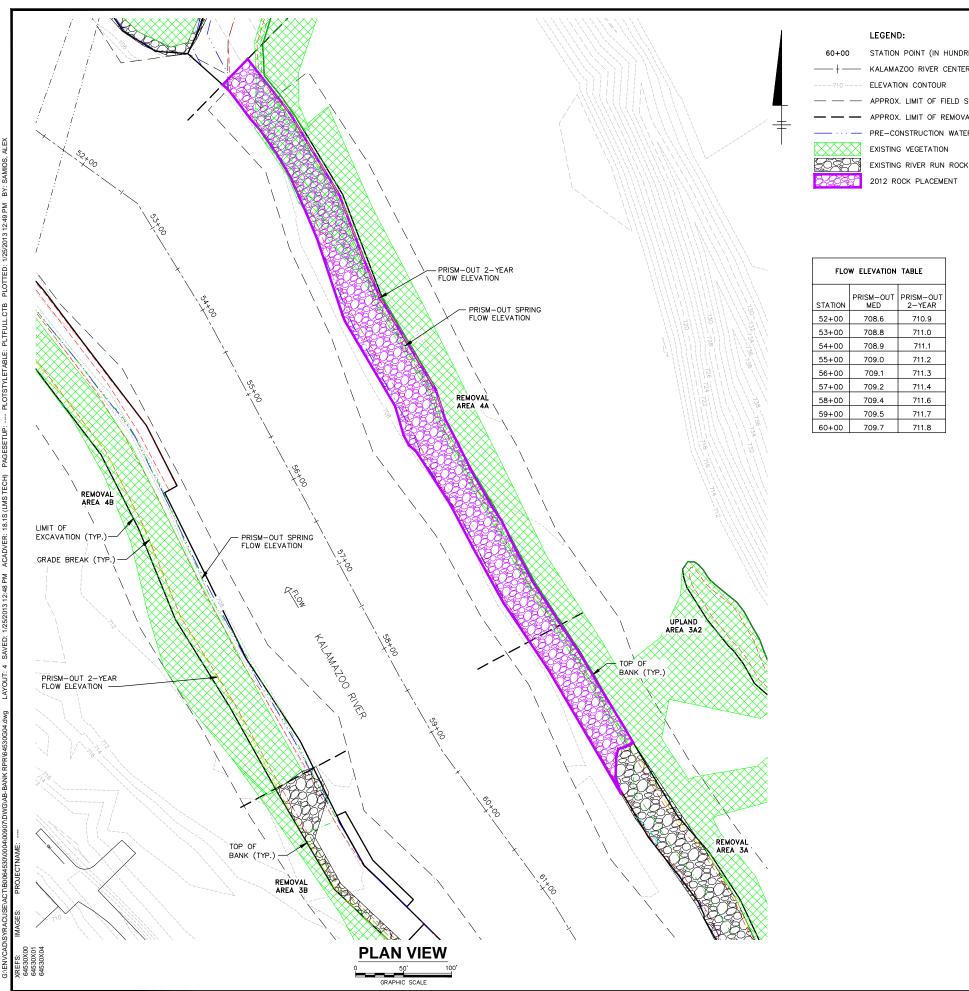
FORMER PLAINWELL IMPOUNDMENT REMOVAL AREA 4A BANK MAINTENANCE PLAN VIEW AND CROSS-SECTION

During the week of December 11, 2012 approximately 75 cy of imported sand fill and 150 cy of angular rip rap was installed along approximately 700 linear ft of bank in Removal Area 4A (Figure 4; River Station 52+50 to 60+00). As described in the November 15, 2012 Technical Memorandum (ARCADIS 2012b), a non-woven geotextile fabric was installed prior to rock placement to protect against erosion behind the rock. The clean fill was installed to isolate exposed residuals in the bank soil from the Kalamazoo River, and the rock was installed to prevent future erosion. Rock was placed from the toe of slope to the prismout 2-year storm water elevation (discharge of 3,845 cubic feet per second [cfs]). As described in the 2012 BCMR (ARCADIS 2012a), clean fill was not required between River Station 52+50 and 55+00; this area only received geotextile fabric and rock.

Upstream of River Station 55+00, a self-launching rock toe was placed in the channel to isolate the maintenance area from the flow of the river. Imported fill was placed behind the self-launching rock toe at a stable slope. Geotextile fabric was installed on the clean fill, and the self-launching rock toe was laid back on the newly formed bank. It should be noted that the bank was not re-built to its former post-

construction dimensions; the existing bank was stabilized by the newly installed rock and fill. Rock and fill were placed using a long-reach excavator situated at the top of bank.

- 1. ANGULAR RIP RAP WAS 8-INCH MEAN DIAMETER ANGULAR STONE WITH A MAXIMUM DIAMETER OF 18-INCHES.
- 2. GEOTEXTILE WAS MIRAFI FILTERWEAVE 700, OR EQUIVALENT.
- 3. LAUNCHING TOE WAS CONSTRUCTED TO ISOLATE THE FILL PLACEMENT AREA FROM THE FLOW OF THE RIVER. DIMENSIONS WERE DETERMINED IN THE FIELD BASED ON OBSERVED FIELD CONDITIONS.
- 4. IMPORTED FILL WAS FROM A VIRGIN, UNCONTAINED SOURCE AND WAS PLACED TO THE REQUIRED THICKNESS TO CREATE A STABLE BANK SLOPE BETWEEN RIVER STATIONS 55+00 AND 60+00. IMPORTED FILL WAS NOT REQUIRED TO CREATE A STABLE SLOPE DOWNSTREAM OF RIVER STATION 55+00. ROCK WAS PLACED ON EXISTING BANK.

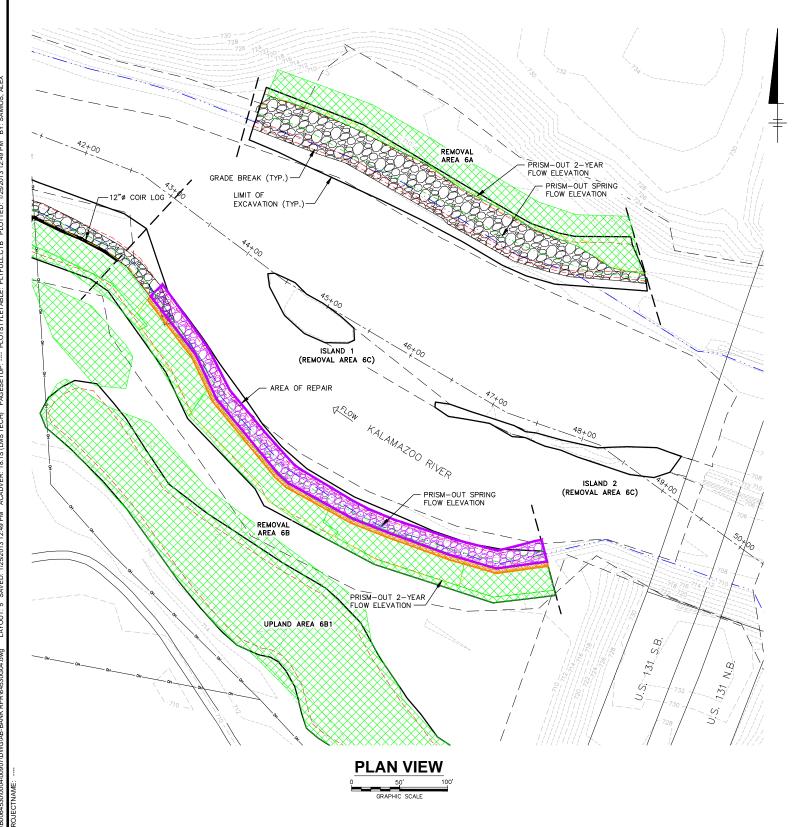
FIGURE 5

During the week of December 17, 2012 approximately 300 cy of rock was installed along approximately 500 linear ft of bank in Removal Area 6B (Figure 5; River Stations 43+50 to 48+00). As described in the November 15, 2012 Technical Memorandum (ARCADIS 2012b), a non-woven geotextile fabric was installed prior to rock placement to protect against erosion behind the rock. Rock armoring was installed from the toe of slope to the top of bank, which provides hard armor to about the prism-out 2-year storm water elevation (discharge of 3,845 cfs). Rock was placed using a long-reach excavator situated at the top of bank. The rock was a mixture of angular rip rap (75 cy) and rounded river run rock (225 cy).

Areas disturbed by construction activities were revegetated with Zone 3 Upland Seed Mix on January 2, 2013. Following seeding, exposed portions of the bank were covered with straw mulch to further protect the bank until vegetation becomes established. Willow trees growing in the area were cut to a height of no less than 2 ft so that equipment situated at the top of bank could reach over existing vegetation to access the slope for maintenance. Willow trees left at this height are expected to re-sprout.

On January 8, 2013, 190 live willow stakes were installed above the prism-out 2-year storm water elevation to support bank stability as woody roots develop and to increase the habitat quality of the floodplain by providing woody habitat. Live staking and incorporation of root wads in the bank is a common practice used to enhance habitat quality and increase bank stability (Fischenich 2001). Live stakes were harvested 3 days before installation while dormant and are expected to remain dormant until spring.

- LIVE WILLOW STAKES WERE INSERTED INTO UNDERLYING SOIL IN TWO ROWS AT 5-FOOT SPACING ON-CENTER.
- LIVE STAKES WERE DORMANT STEM CUTTINGS OF 1 TO 3 INCHES IN DIAMETER AT THE TOP AND AT LEAST 36 INCHES IN LENGTH. CUTTINGS WERE CLEAN ANGLED CUTS AT THE BOTTOM AND FLAT CUTS AT THE TOP, WITHOUT SPLIT ENDS, AND HAD AT LEAST TWO LIVE LATERAL BUDS ON THE PORTION OF THE STAKE THAT WAS ABOVE—GROUND.
- 3. AREA VISIBLE ABOVE THE WATER LINE WAS TOP-DRESSED WITH ROUNDED RIVER RUN ROCK TO THE EXTENT PRACTICAL BASED ON STOCKPILED QUANTITY.
- 4. ROUNDED RIVER RUN ROCK WAS 6-INCH MEAN DIAMETER ROUNDED STONE WITH A MAXIMUM
- 5. ANGULAR RIP RAP WAS 8-INCH MEAN DIAMETER ANGULAR STONE WITH A MAXIMUM DIAMETER OF
- 6. GEOTEXTILE WAS MIRAFI FILTERWEAVE 700, OR EQUIVALENT.

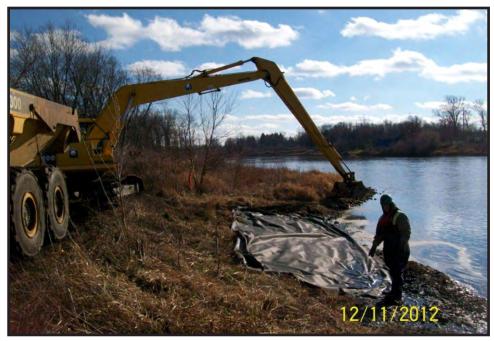
Placing geotextile on clean fill material in Former Plainwell Impoundment Removal Area 4A.

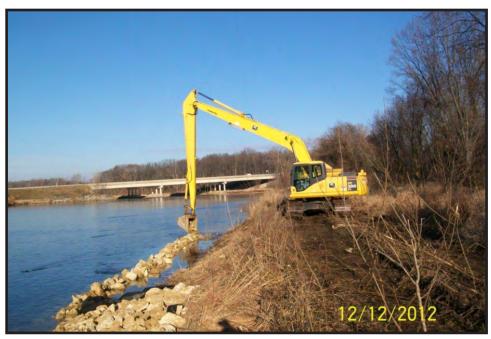
Installation of self-launching rock toe in Former Plainwell Impoundment Removal Area 4A.

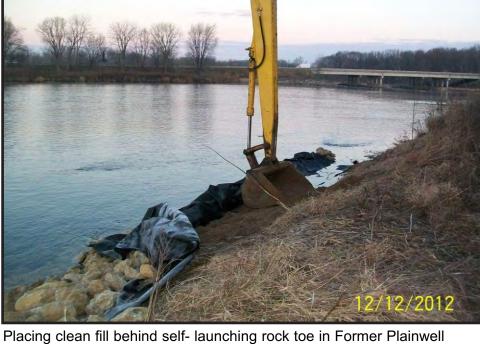
Impoundment Removal Area 4A.

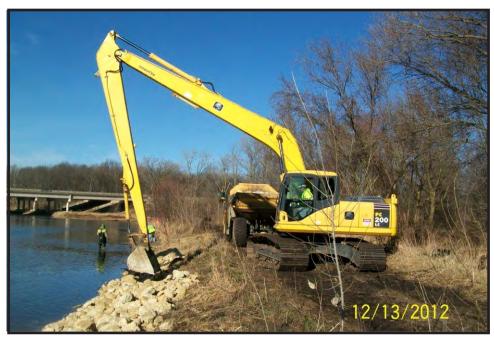
Installation of rock on bank in Former Plainwell Impoundment Removal Area 4A.

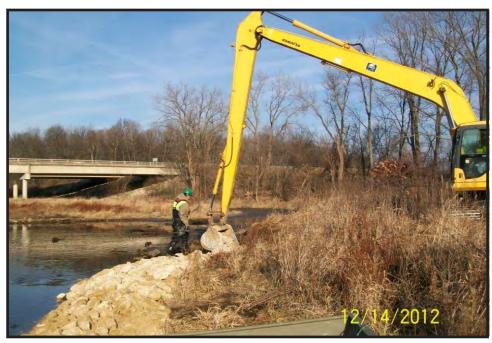
Installing rock at downstream end of Removal Area 4A in Former Plainwell Impoundment.

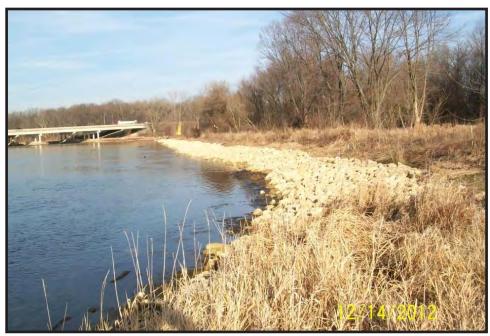
View looking west of completed bank maintenance in Former Plainwell Impoundment Removal Area 4A.

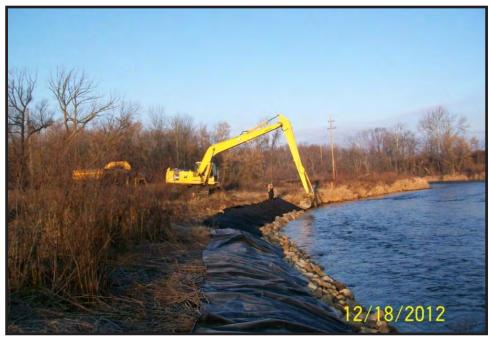
Installing rock in Removal Area 6B in Former Plainwell Impoundment.

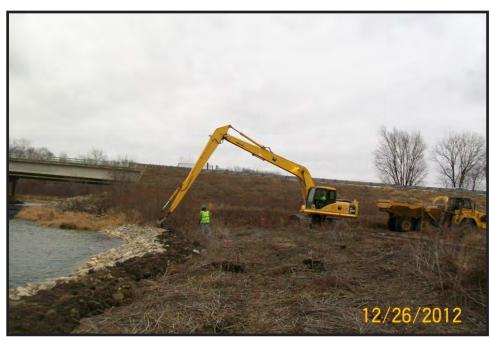
Installing rock in Removal Area 6B in Former Plainwell Impoundment.

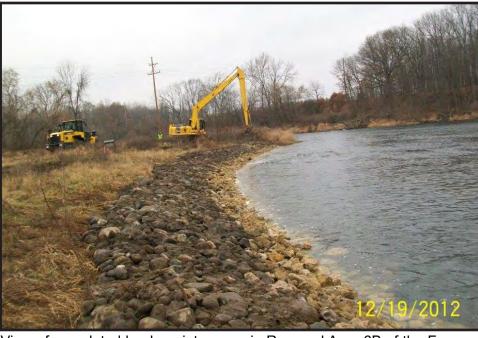
View of completed bank maintenance in Removal Area 6B of the Former Plainwell Impoundment.

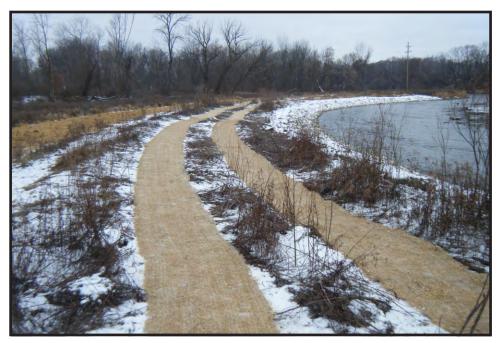
View of completed bank maintenance in Removal Area 6B of the Former Plainwell Impoundment.

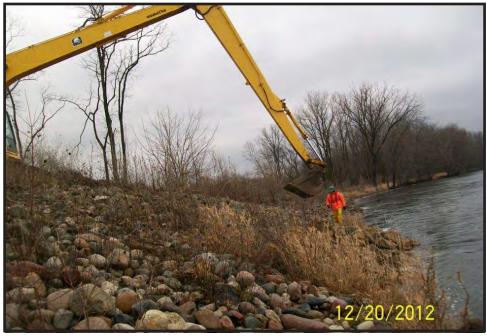
Placing rock near the Western Channel of the Former Plainwell Impoundment.

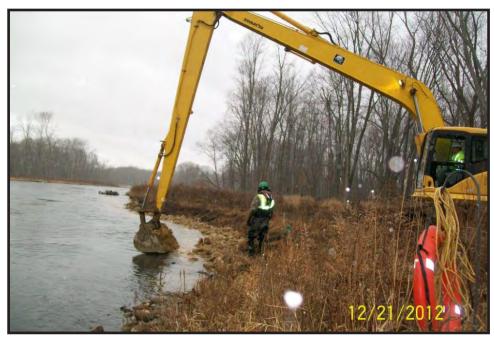
Placing rock on the bank of Removal Area 3A in the Plainwell No. 2 Dam Area.

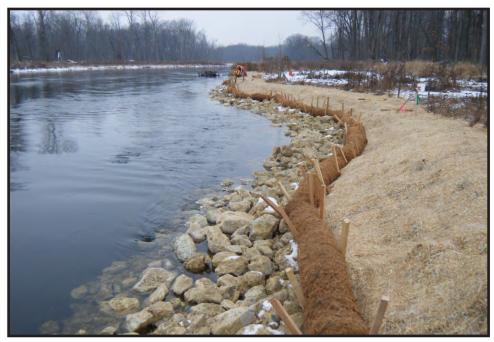
View of completed bank maintenance in Plainwell No. 2 Dam Area Removal Area 3A.
